Observation of works at Fish Hill Square, Royston, Hertfordshire, 2011

North Hertfordshire District Council

Archaeological Report 37

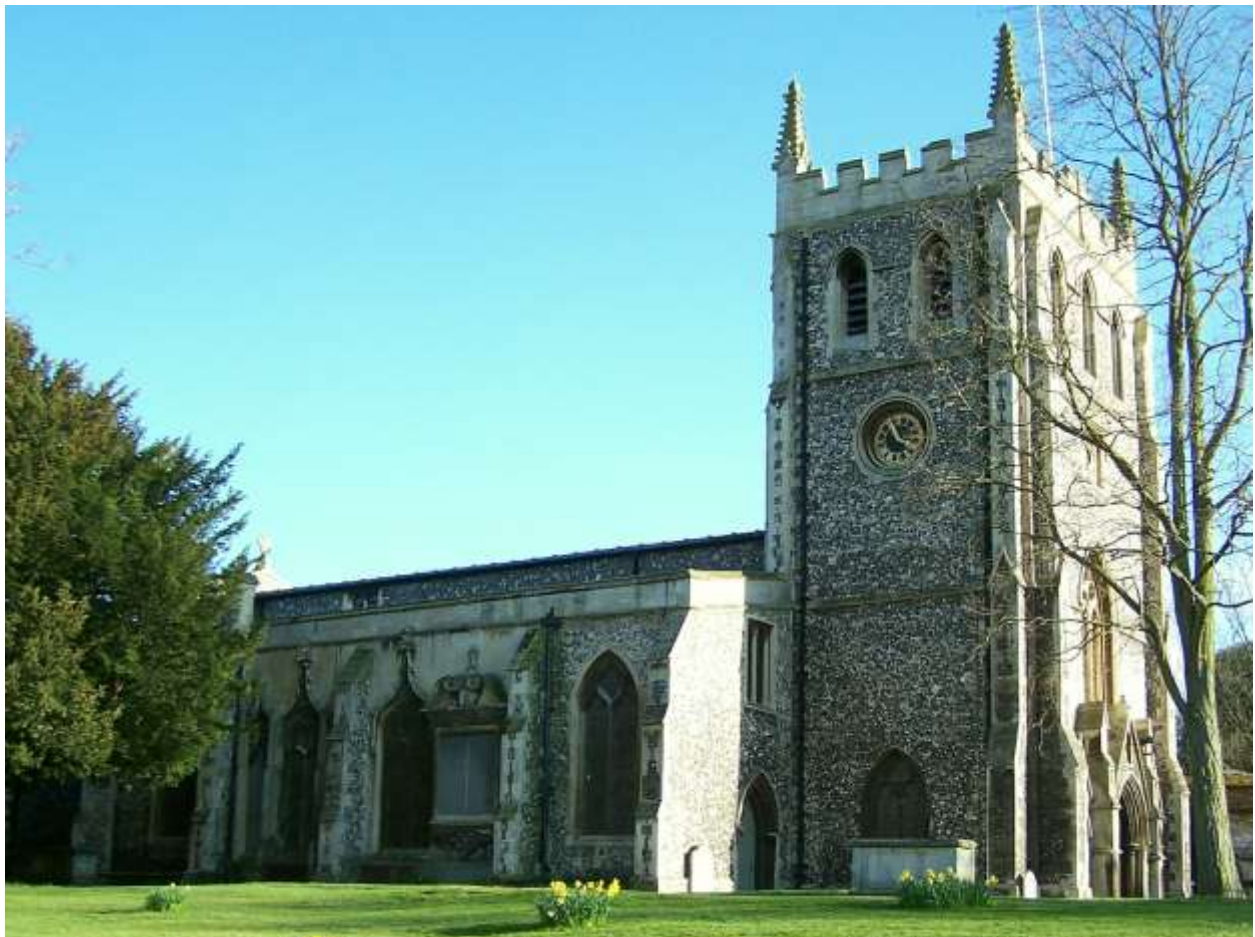
Figure 7: St John's Church, the former Priory church, March 2007

The Priory and its church are the best survivals from the medieval town (Figure 7). Although much obscured by later alterations, these buildings still possess some of their monastic architecture (Pevsner & Cherry 1971, 20), such as a pier with four quatrefoil sections with keeled diagonal shafts and complexly moulded arches (Pevsner & Cherry 1971, 282). The nave and aisles of the present church are the altered remains of the conventual quire, quire aisles and chancel, the tower having originally been

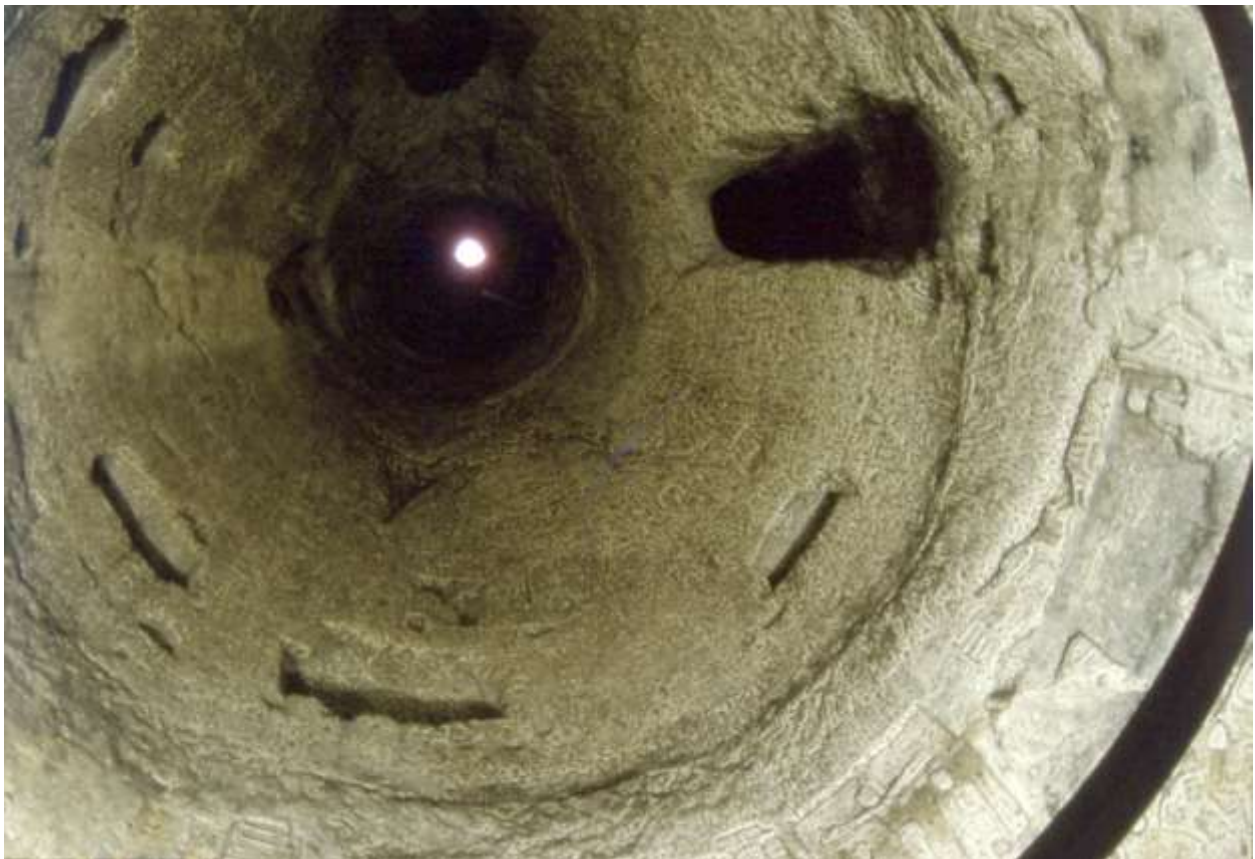
Figure 8: Royston Cave in 1996, looking up to show the shape of the dome

The form of the cave is not entirely without parallel, as has been claimed, though: it has already been noted that bottle-shaped chalk quarries appear to have originated in the Late Iron Age and to have continued to be created as late as the medieval period. Quarrying for the construction of the Priory late in the twelfth century would provide a plausible context for the creation of the cave. Documentary evidence shows that there was a hermitage in the town c 1506, which was purchased by the lord of the manor, Robert Chester, in 1540; if the Augustinian canons had indeed created the cave as a quarry, they may well have continued to use it, adapting it late in the fifteenth century for use as an anchorite's cell. The function of the cave remains unclear and, although new suggestions are often made, it is unlikely that a definitive answer will be found.

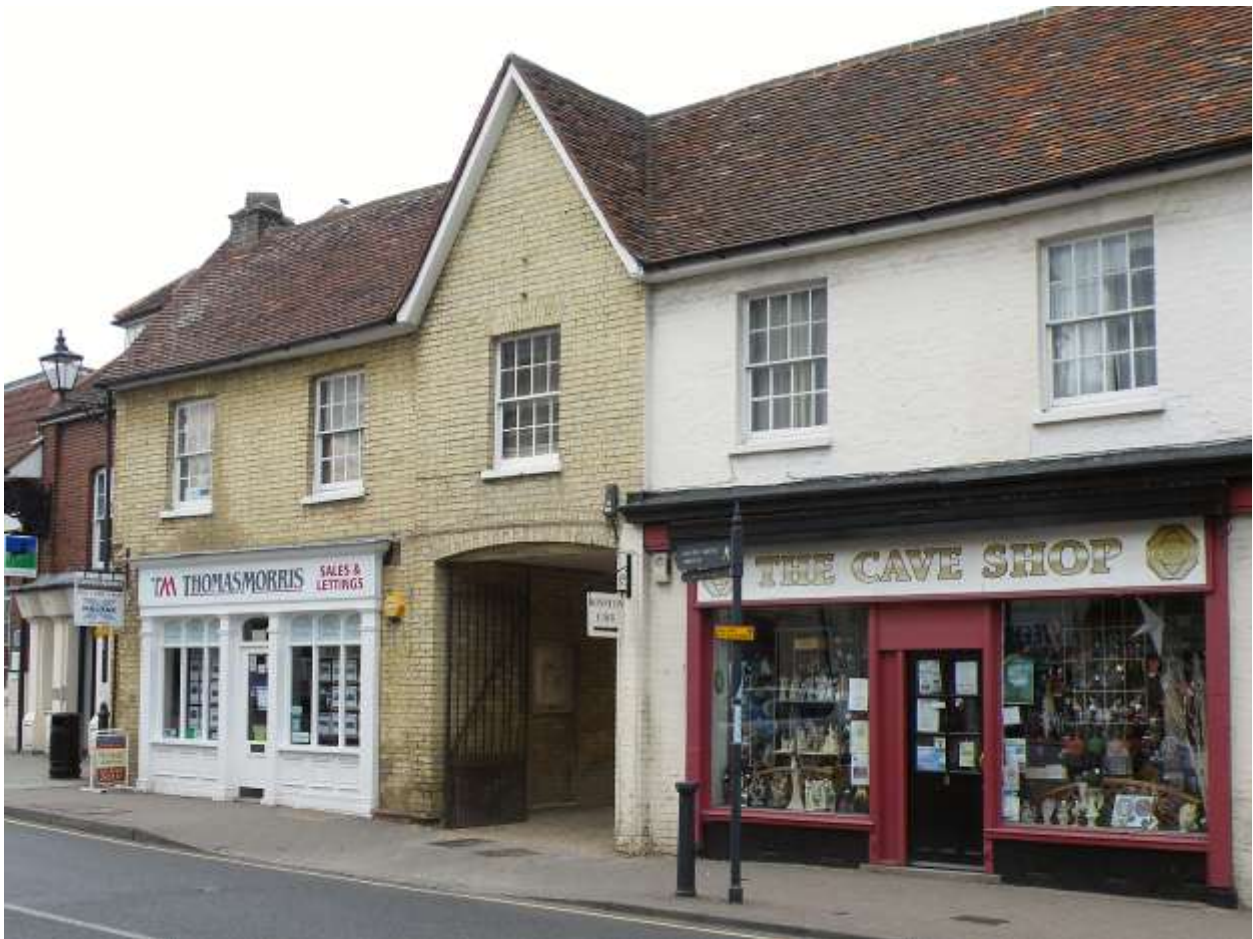
Figure 9: Cambridgeshire gault bricks in the 1926 refronting of 6-8 Melbourn Street, formerly the White Horse Inn

There was an early nineteenth century "*vogue for yellow and white bricks*" (Pevsner & Cherry 1971, 59), which were made from gault clays containing enough lime to counteract the usual reddening effects of iron. They are known in Bedfordshire as Arlesey Whites (Ashworth 1998a, 4) and in Cambridgeshire as Cambridge Gault Bricks, a product of the Ely brick-making industry (Lucas 1993, 158); the latter source is more likely in Royston (Figure 9). The use of such materials, alongside the growth and industrial changes, would have made the town almost unrecognisable within the space of 100 years. Nevertheless, the town maintained many of its medieval features throughout this time of change (Plowman 2008, 182).

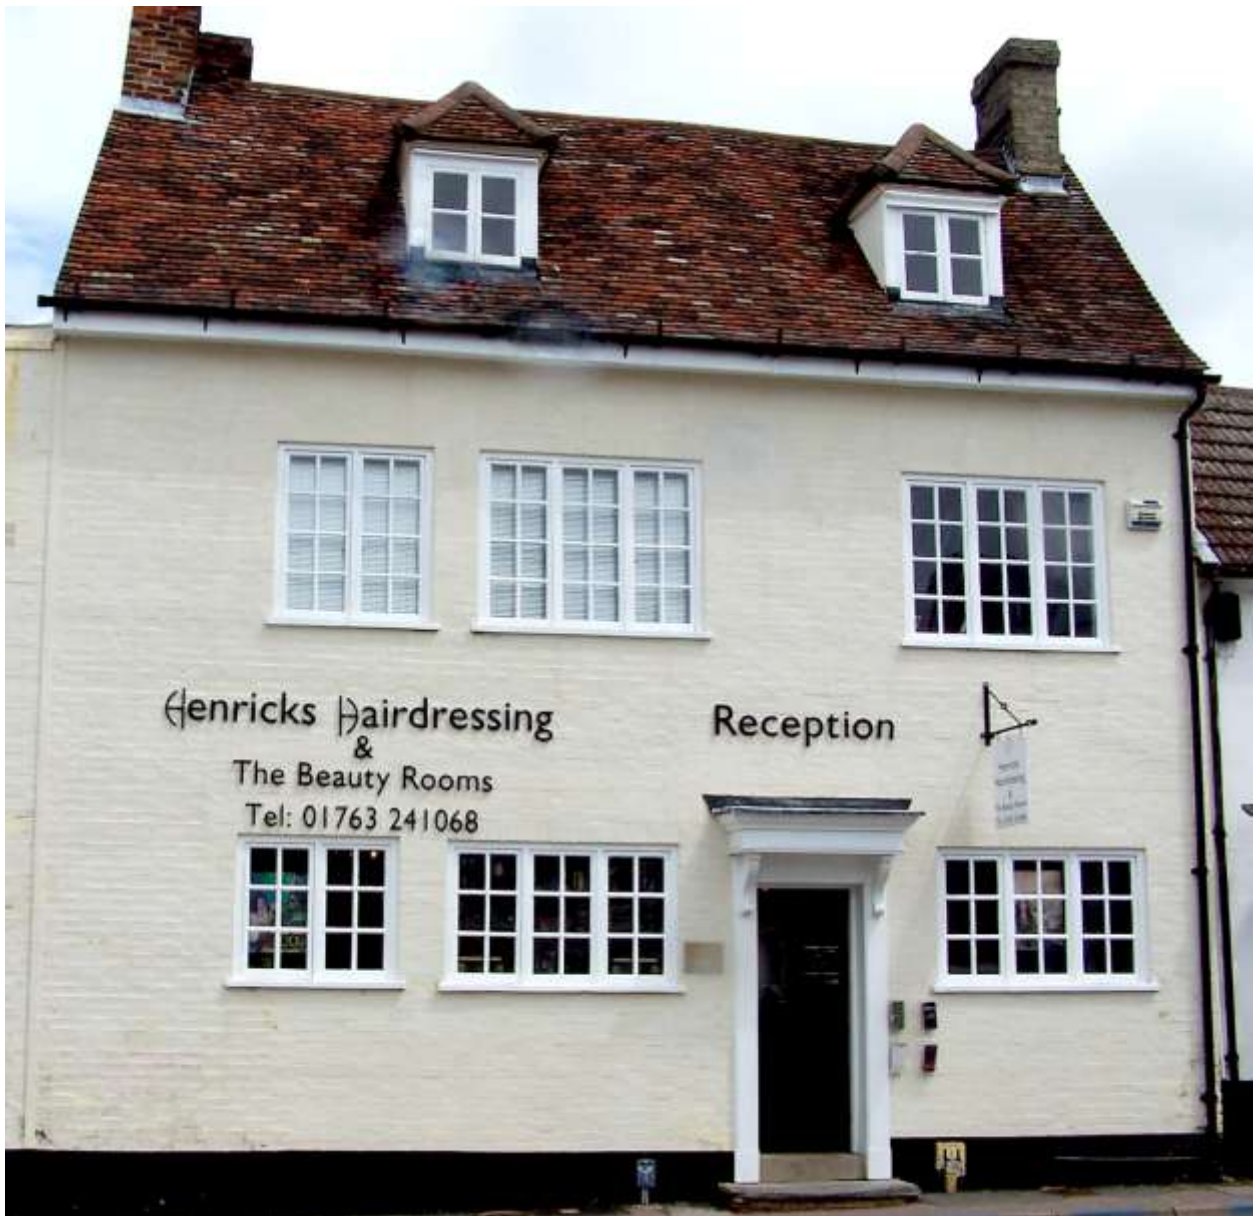
Figure 10: 2 Fish Hill, a seventeenth-century timber framed building refronted with colour-washed brick

and 1347651 are subdivisions of a single eighteenth-century building in High Street. Only one of these buildings, 1102059 (2 Fish Hill) actually fronts Fish Hill Square (Figure 10).

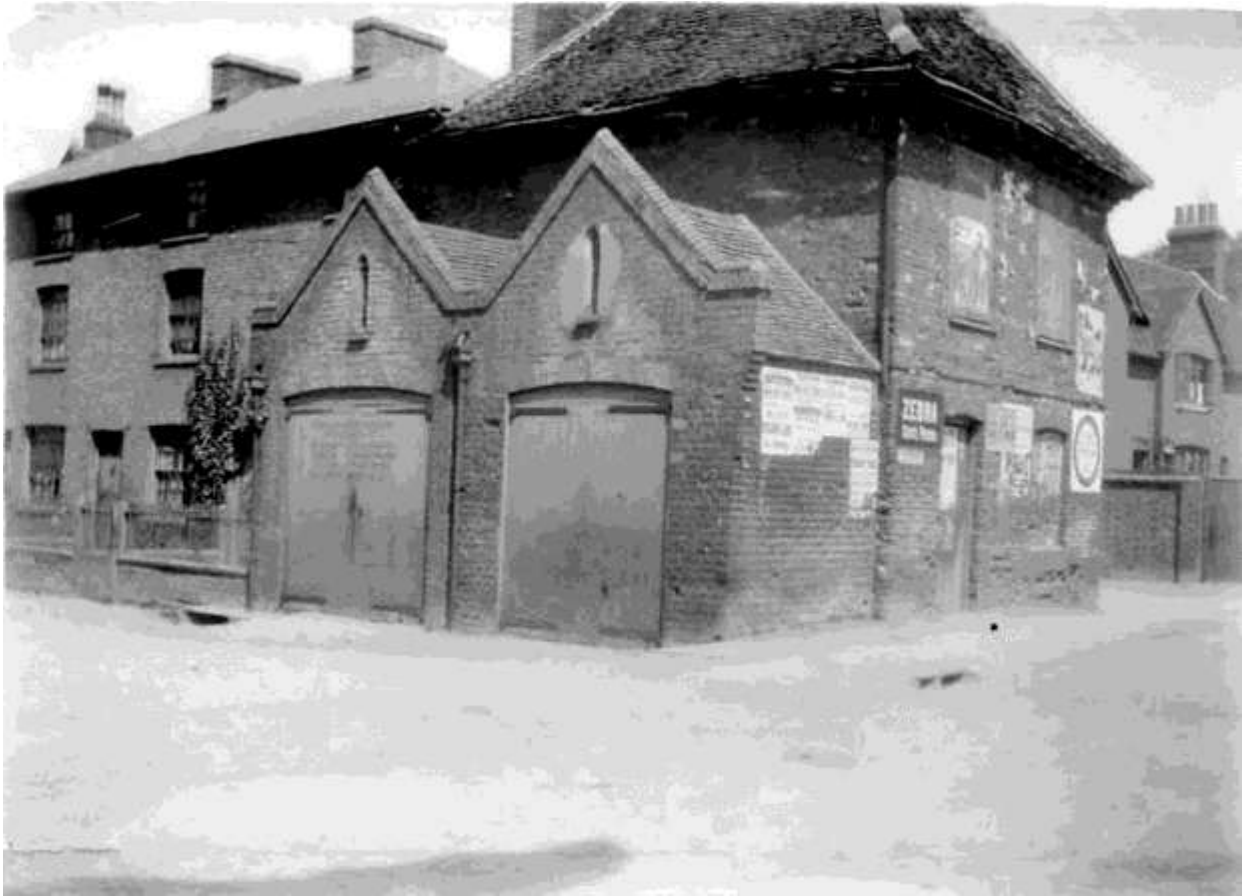
Figure 12: the earlier Fire Station and The Cage before demolition in 1897 (© Royston Museum)

A photograph showing The Cage and the earlier Fire Station has already been reproduced (Figure 12, *above* page 26). This shows The Cage to have been a roughly square brick building with a hipped old tile roof, door to John Street and two (blocked) windows to the first floor. This may have been an alteration

when the Parish Rooms were converted to a lock-up or it may date the photograph to a time when the building was derelict before demolition in 1897. The old Fire Station can be seen to consist of two gabled brick structures with wide doors for (presumably) two fire engines; the northernmost of the two seems to have been slightly broader than the southern.

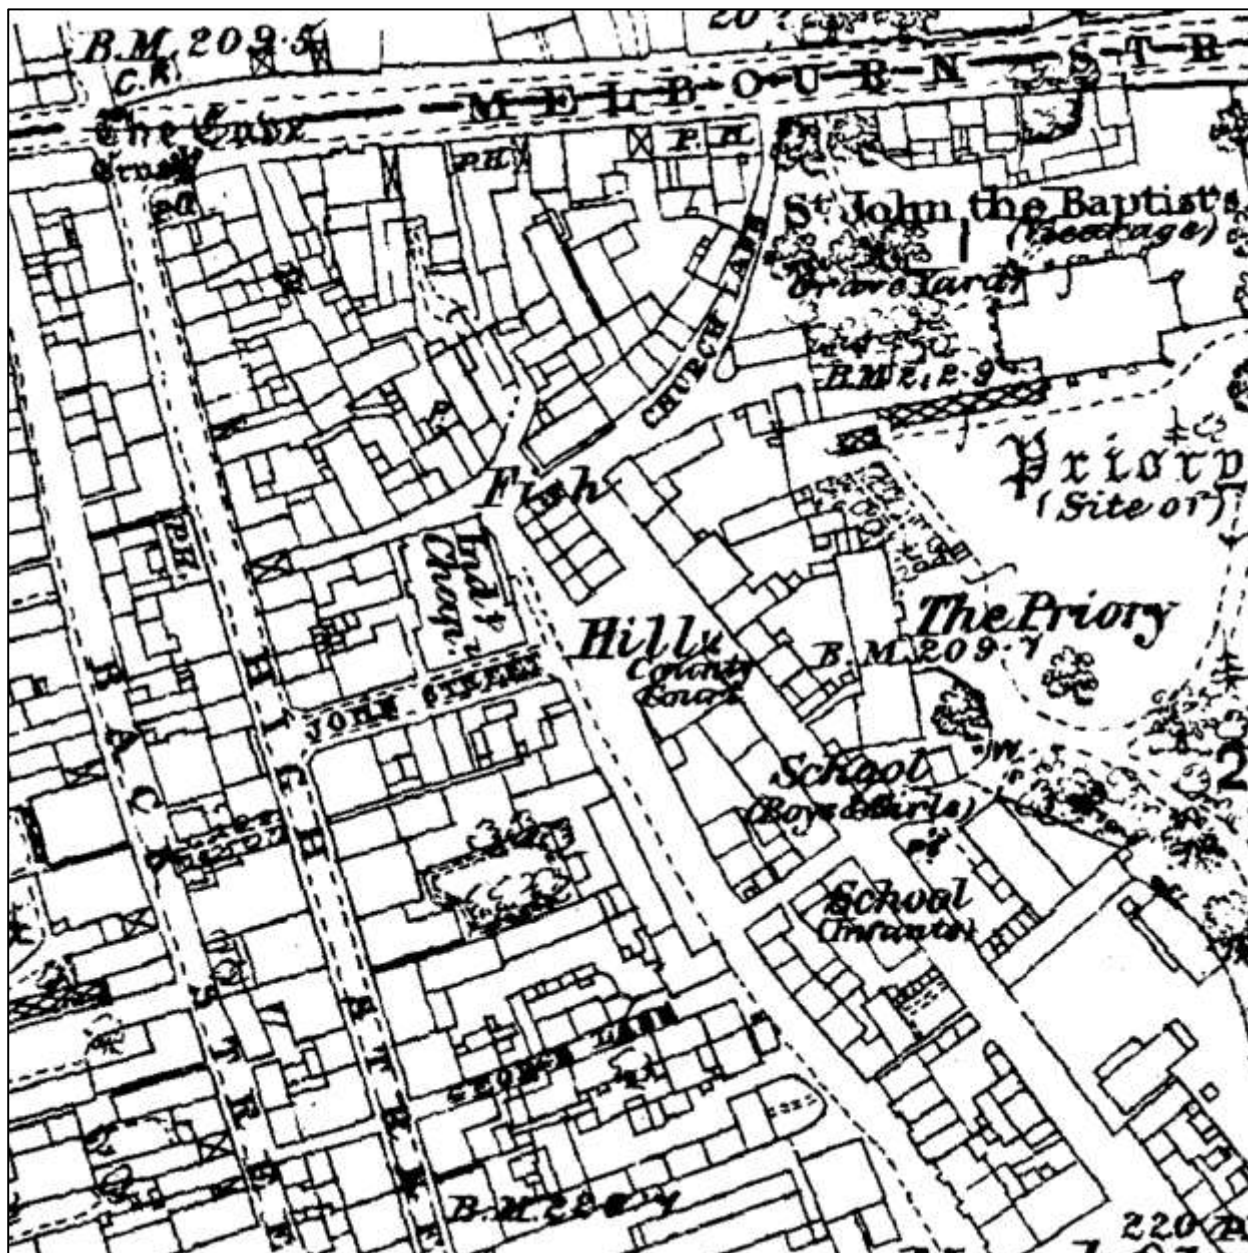
Figure 16: Ordnance Survey First Edition 1:2500 map (1887)

The most useful of the early Ordnance Survey maps to show Royston is the First Edition (1887) 1:2500 map (Figure 16). This series was published in county sets, so the Hertfordshire map ignores the town north of Baldock Street and Melbourn Street. This is the first map to show Fish Hill and Market Hill in any detail; it labels the County Court building and the two schools, and shows the site of Fish Hill Square as occupied by five properties and gardens. The photograph of the earlier Fire Station makes it clear that

the two south-westernmost rectangles are not gardens, unlike the three to the north, but the double-bayed Fire Station; it also wrongly subdivides The Cage into two properties. This map is the first to show John Street and, although it does not name it, Jepps Lane.

It also shows the complexity of property boundaries to the north-west of Fish Hill and Market Hill. While the medieval burghage plots of High Street are, to a certain extent, still visible in the later nineteenth century pattern of pattern of boundaries, no such patterning is visible in most of the area between Fish Hill and Melbourn Street. Several possibilities may be suggested. One is that this area lacked burghage plots because Melbourn Street was part of a through route that was not properly incorporated into the layout of the medieval town. It is also possible that, as previously suggested, Fish Hill and, possibly, Market Hill originally extended northward to Melbourn Street and that the confused pattern of boundaries in this area is a result of later haphazard infill of a formerly open space. Another possibility is that these property boundaries reflect the development of Jepps Lane and Church Lane, the latter presumably after the dissolution of Royston Priory.

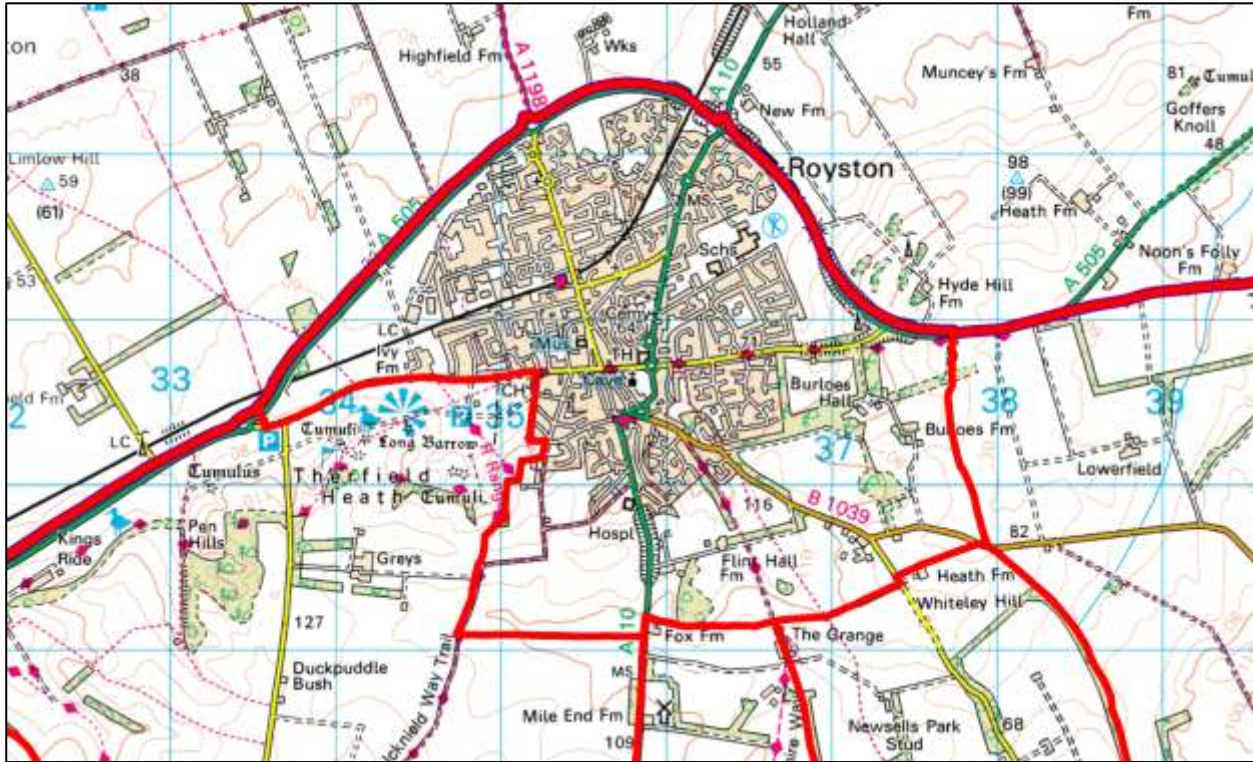
Figure 18: Ordnance Survey 1:50,000 map (2011)

The current (2011) 1:50,000 map reproduced here (Figure 18) has a GIS overlay showing the current parish and county boundaries within North Hertfordshire. This map clearly shows the enormous growth of the town since Bryant's map of 1822, particularly to the north. In part, this is because the railway lies on this side of the town, but it is also because the land is flatter in this area and easier to develop.

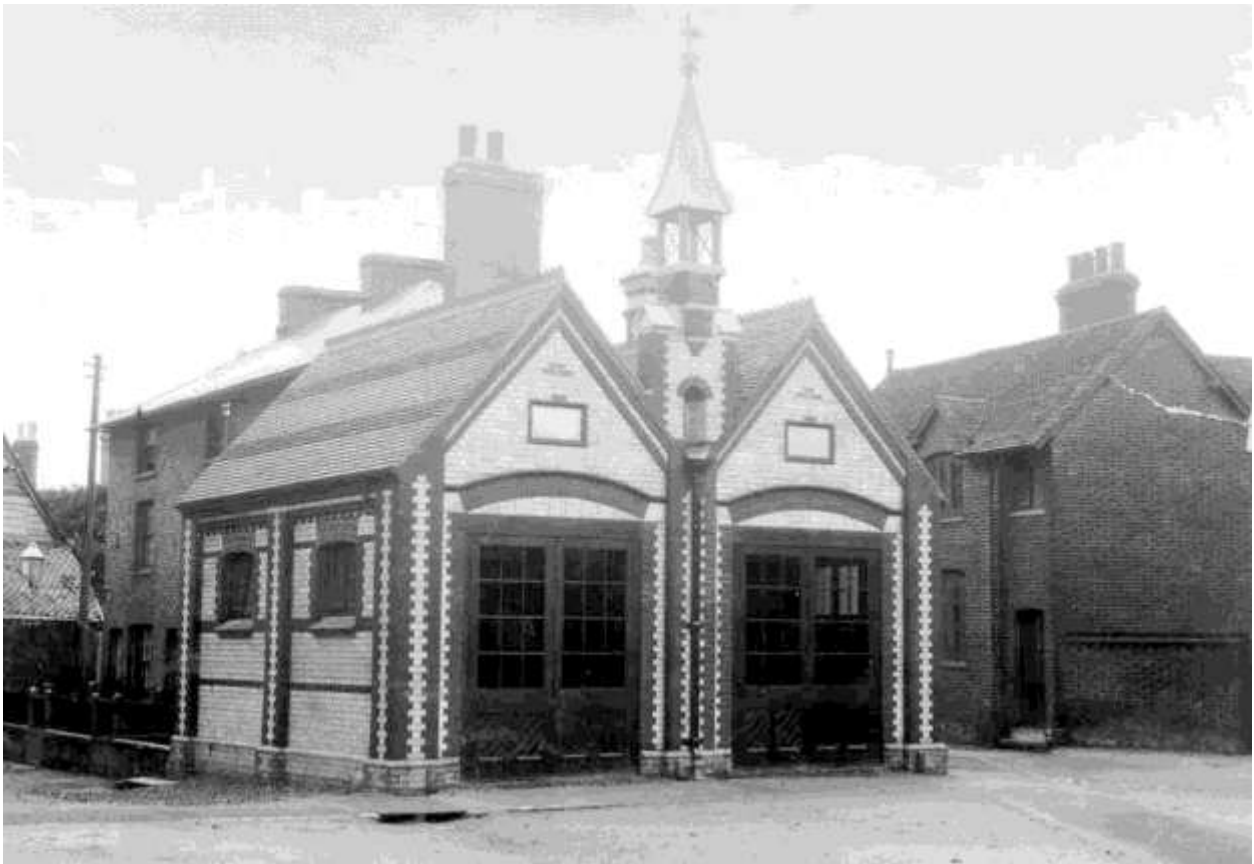
Figure 20: the Jubilee Fire Station, date unknown (© Royston Museum)

The new building was larger and more elaborate than the shed-like structure it replaced (Figure 20). Like the earlier building, it consisted of two bays with gables facing the street, although it now faced John Street and the County Court rather than Market Hill and the Congregational Chapel. It was of Cambridge Gault brick, with darker (red brick?) quoins and detailing around the doors, windows and two horizontal bands. The roof was tiled, with two bands of a contrasting (darker?) colour, a central bellcote at the front between two pitched roofs, open on all four sides, with an arched opening at the base for drainage and a socket for a flagpole set in front of it and a steeply pitched roof.

Set into the left (west) gable was a datestone commemorating the construction of the Jubilee Fire Station, while the right (east) gable contained a stone recording the discovery of the datestone for the former Parish Rooms (later known as The Cage). It has not been possible to read the details of the inscriptions on the published copies of the photographs, although the first line of the left hand stone

reads ERECTED and the bottom line probably reads 1897; the second and third lines of the right hand plaque read UPON THE SITE OF THE OLD PARISH, while the sixth (bottom) line reads 1718.

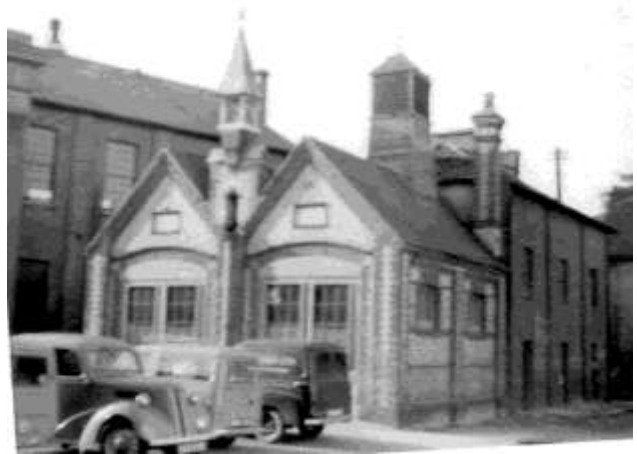
Figure 23: the Jubilee Fire Station, probably 1950s (© Royston Museum)

A later photograph (Figure 23), probably dating from the 1950s to judge from the vehicles parked in front of the Jubilee Fire Station shows that a tower had been added to the northern end of the right hand (eastern) part of the building. The tower appears to have been of wooden construction and its upper part was louvered. It was topped by a pyramidal roof. It may have been for drying hoses after use; it is curious that a view from the church tower, dated c 1900 (not reproduced here), shows this tower when it is clearly absent from other early photographs, which suggests that it was added soon after the construction of the Jubilee Fire Station.

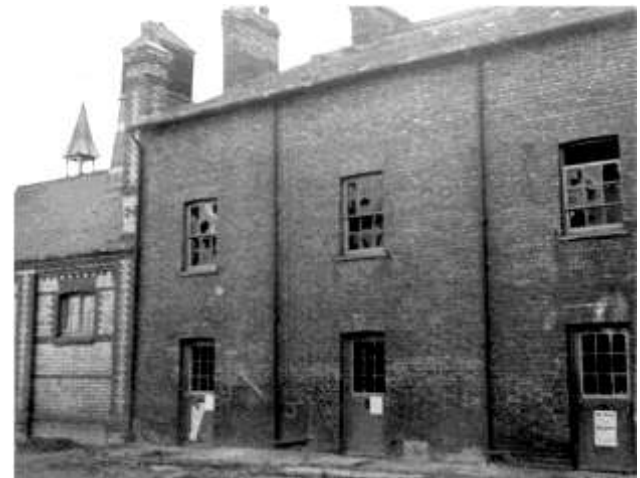
Figure 22: the rear of the tenements, probably 1950s (© Royston Museum)

The rear wall of the three tenements to the north of the Jubilee Fire Station is also visible in this photograph. They each have a door opening into the street, with no yard area, and a single window above. A second photograph (Figure 22), probably contemporary with this, shows the three properties in a derelict condition, their upper storey sash windows (two groups of 2×3 panes each) partly smashed and the windows in the doors (3×3 panes in each) completely smashed. This may date both this photograph and Figure 20 to a time immediately before the demolition of the buildings in 1960. The properties can be seen to be of (red?) brick, with a hipped slate roof, of two and a half storeys (Figure 12, which depicts the Market Hill frontages of the buildings before 1897, shows that there were low windows immediately below the eaves). There were separate chimney stacks for each property with no chimneypots. The buildings were devoid of any decorative elements, indicating their lowly status, although the small gardens at the front of the properties, facing Market Hill, had low brick walls topped with iron railings.

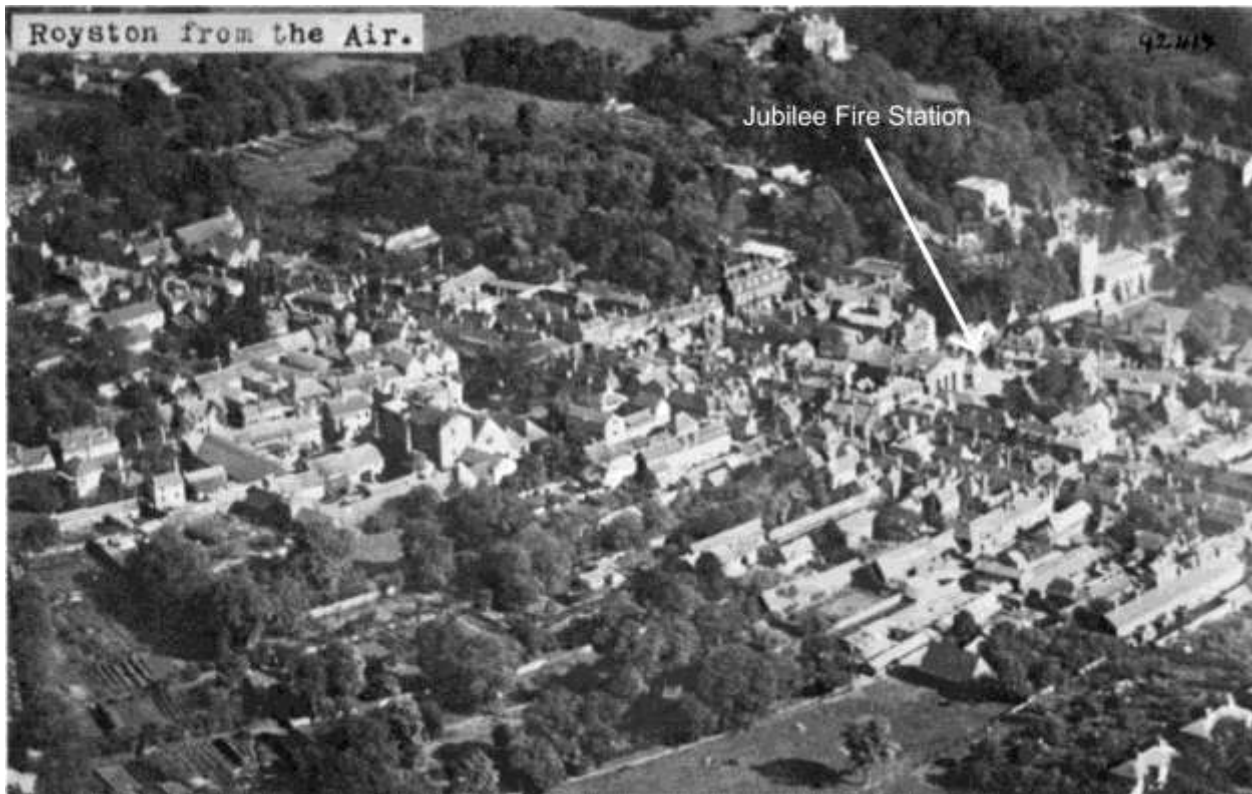
Figure 25: Royston from the air in the 1920s (after Smith 1983, Plate 1)

There is an early (1920s) aerial view of the town from the south-west, reproduced as a picture postcard (Figure 24). Although taken at some distance from Fish Hill Square, it is possible to recognise the south front of the Jubilee Fire Station (arrowed), largely because of the presence of the neoclassical façade of the John Street Congregational Chapel, although no details are visible. The tenements are hidden by the Chapel, although some of the buildings on the east side of Fish Hill are visible. The principal interest of the photograph is in showing how development of the town had barely begun to the north of Baldock Street and Melbourn Street, other than along Kneesworth Street and how the former 'Palace' buildings dominate the area to the north-east of the crossroads. Almost thirty years after the town had been brought into a single county, there were still differences in growth between the two halves.

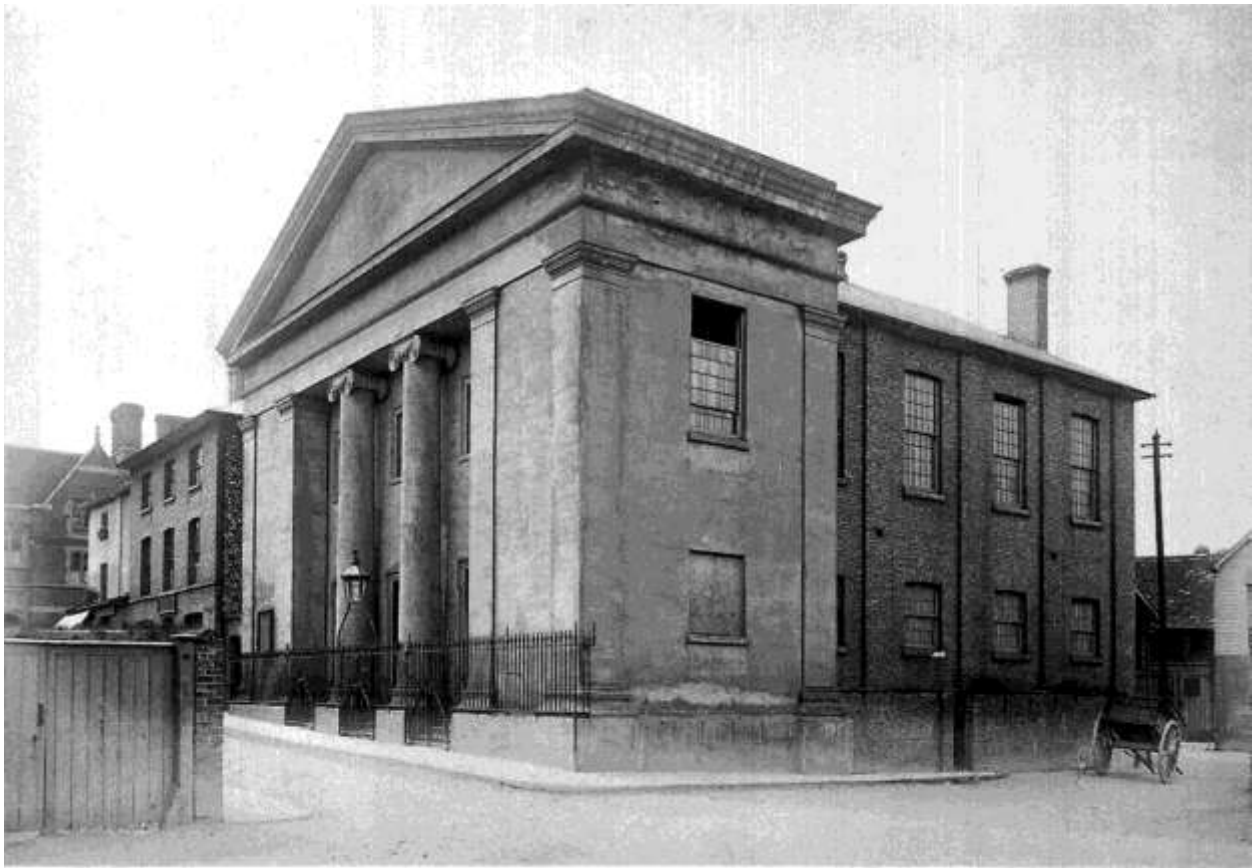
Figure 26: John Street Congregational Chapel (after Ketteringham 1992, 37)

The northern end of Market Hill and the northern side of John Street were dominated by the Congregational Chapel until its demolition in the 1960s (Figure 26). The main body of the building was of brick, with two rows of sash windows, account for the four northernmost bays; the fifth, southern, bay projected beyond the sides of the brick part of the building and consisted of a massive neoclassical façade, possibly of stone but more likely rendered, with a plain triangular pediment supported on two Ionic columns, with three doors to John Street and three windows above. There were iron railings and gates to the street frontage.

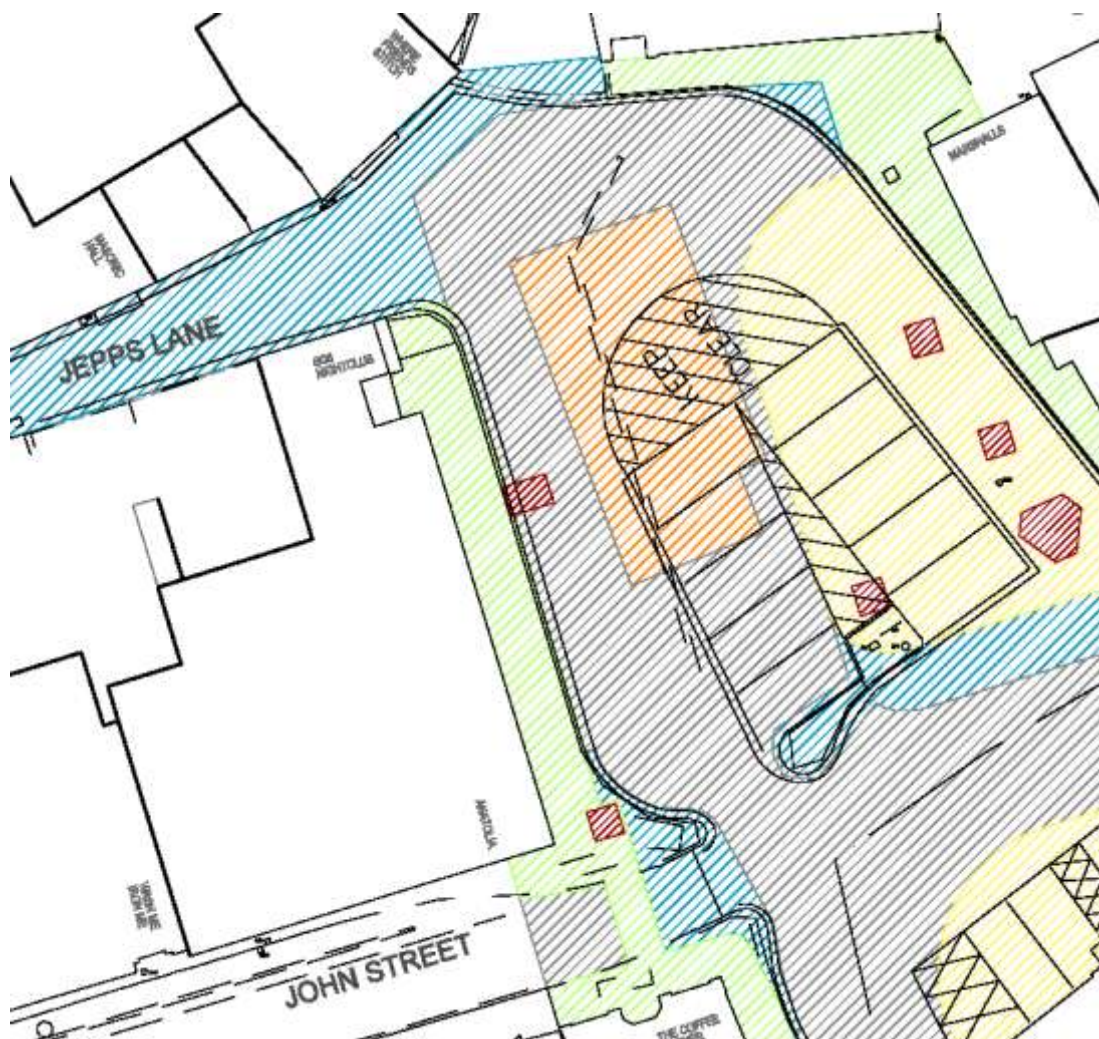
Figure 29: Fish Hill Square (1:300); the position of the attenuation tank is shaded orange

The excavation was conducted by the contractors for North Hertfordshire District Council using a 360° tracked JCB mechanical excavator fitted with a one metre toothed bucket. This was used to strip the overlying deposits of tarmac and its make-up layers (see below for details of these deposits) before beginning to empty the cellars of the properties that had formerly occupied the site. The spoil was placed to one side of the excavation to be removed from site by lorries. Observation of material removed from the site had to be undertaken from outside the fencing around the site for safety reasons.

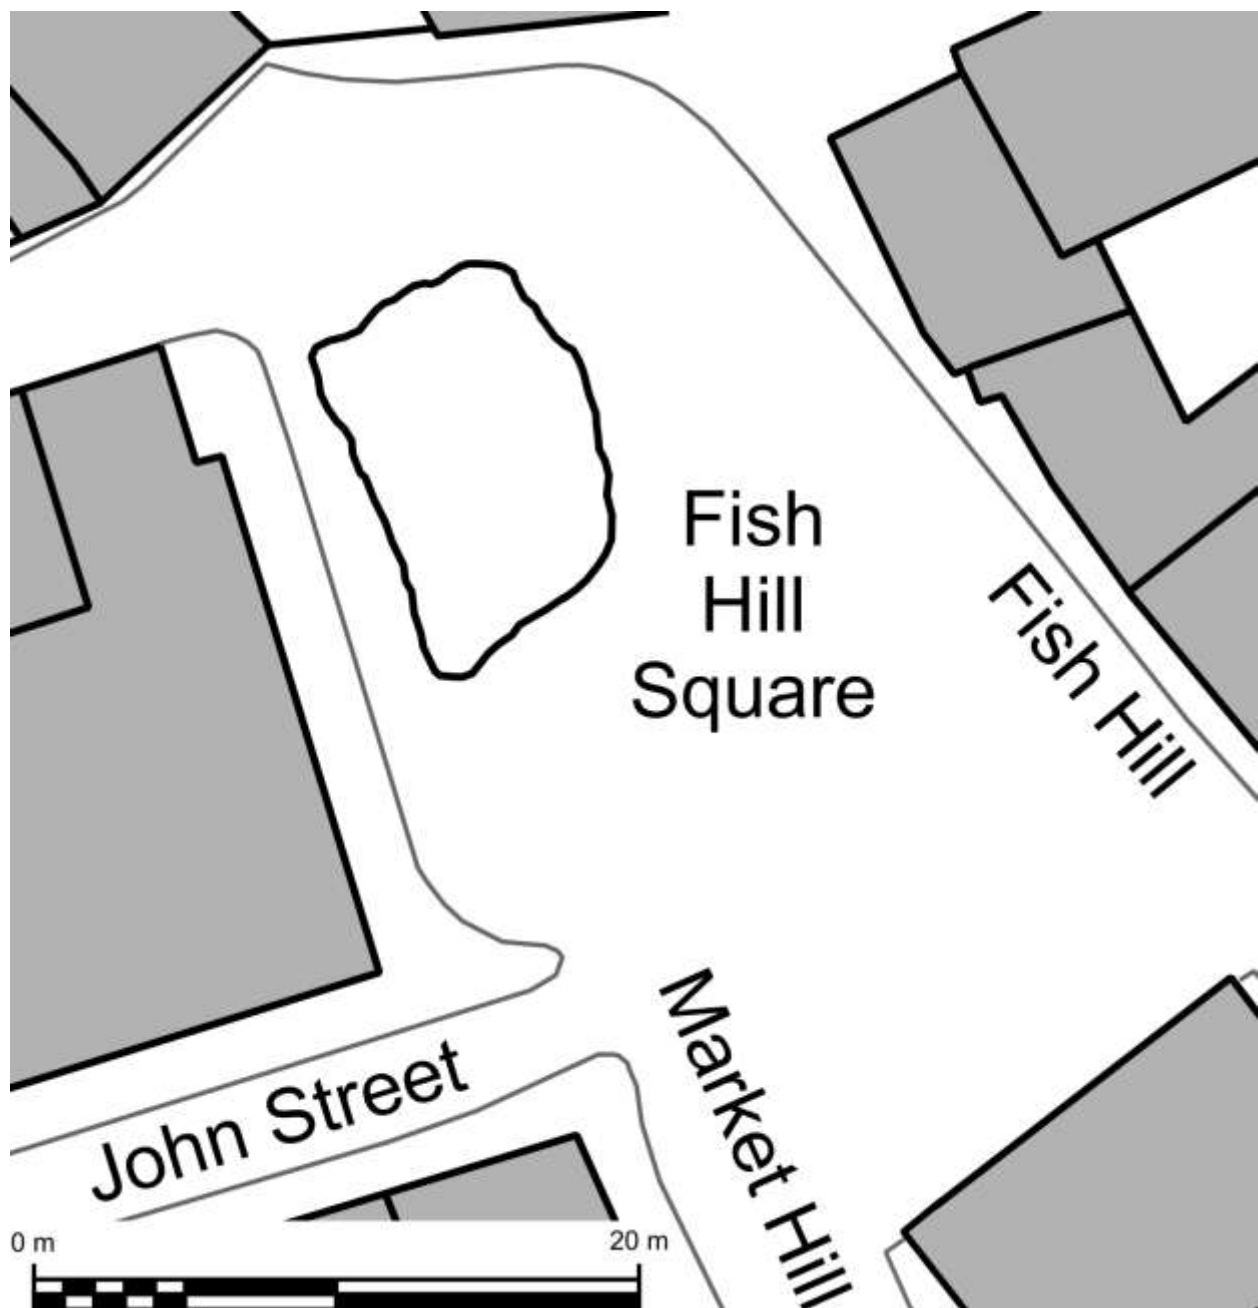
Figure 30: location of the excavation trench (1:250)

Detailed site recording was necessarily restricted to the edges of the excavation (see the location plan in Figure 30). Here, exposed archaeological deposits and features were visible on the southern and western edges of the trench; where features could be seen, they were cleaned rapidly by hand using WHS pointing trowels and a more rapid clean was undertaken in other areas that were not obviously solid chalk, revealing several additional features. Following cleaning, each feature was located within the section (measured by distance from one edge of the trench and depth from the present surface), sketched at a scale of 1:10, photographed and recorded on pro forma record sheets. The eastern part of the northern edge and the eastern edge had substantial areas of poorly consolidated brick rubble left in section and, for safety reasons, no attempt was made to clean these.

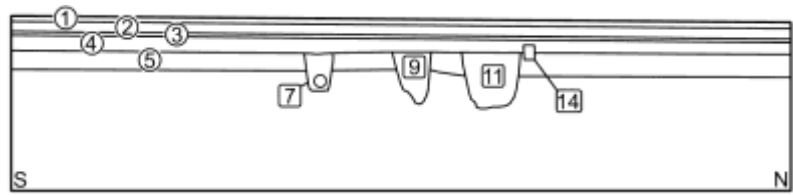
Figure 31: the western (east facing) section (1:100)

This appears to have been laid as a levelling deposit for surface (1) and was probably of late twentieth-century date. It may have been laid to counter the slumping observed where surface (3) lay over infilled cellars.

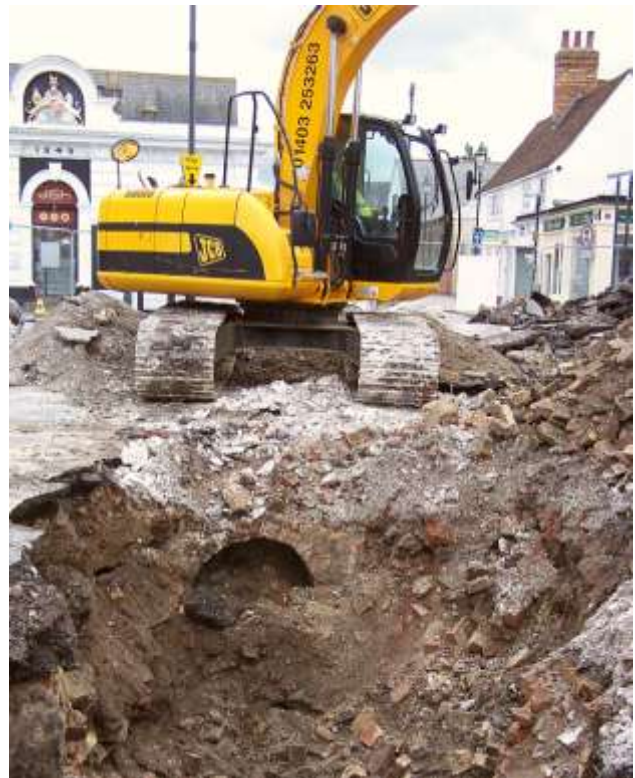
Figure 33: recess in wall [37] during excavation

The eastern side of the excavation was dominated by a series of walls forming at least two distinct 'rooms'. All the walls that lay within the area for the attenuation tank were removed by mechanical excavator, with no opportunity for detailed measured recording; those elements that remained on the morning when recording took place were partly obscured by the unconsolidated rubble (40) (Figure 33). In the

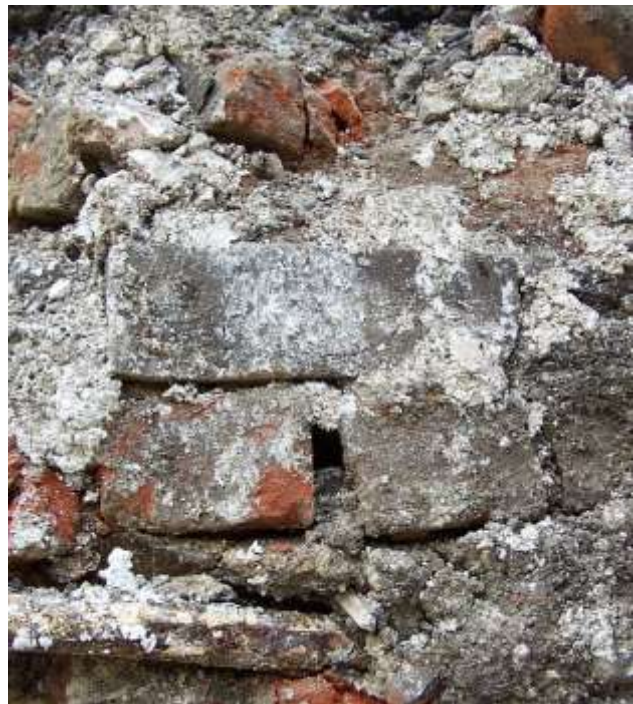
Figure 34: brick foundations [14]

This was probably part of the foundations for the front garden wall of the nineteenth-century tenement block facing Market Hill.

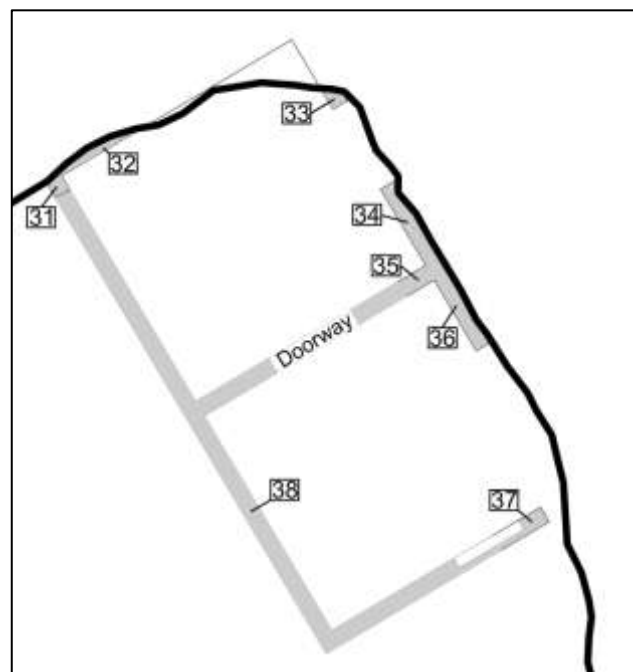
Figure 35: walls observed and inferred (scale 1:100)

To the east, wall [32] presumably joined wall [33] at right angles, although the angle was obscured by unexcavated portions of backfills (39) and (40). Wall [33] ran parallel with wall [31], but 1.07 m south of its junction with [32], it terminated. There was then a gap some 1.23 m wide, after which the line of wall [33] was continued by wall [34]. After 1.17 m, this wall joined wall [35], which ran parallel with wall [32]. These wall

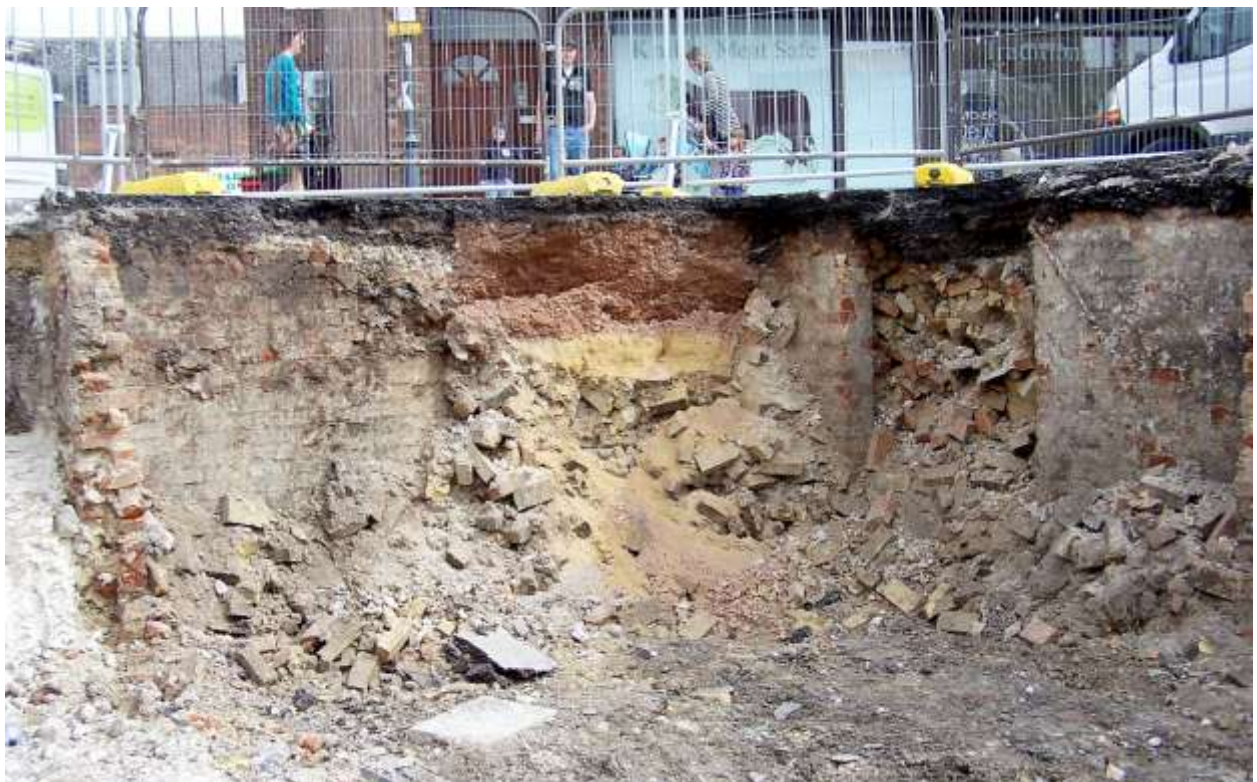
Figure 36: walls [31], [32], [33] and [34]

Walls [31], [32], [33], [34] and [35] formed a cellar beneath the northernmost of the nineteenth-century tenement properties fronting Market Hill before demolition in 1960 (Figure 36). Photographic and map evidence indicates that they would have lain beneath the front rooms of the properties. The doorway in the eastern walls ([33] and [34]) appears to have given access either to a second room of cellarage that would have lain beneath the rear room of the property or to a staircase giving access to the cellars.

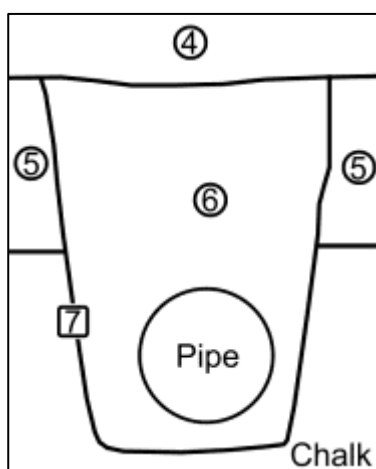
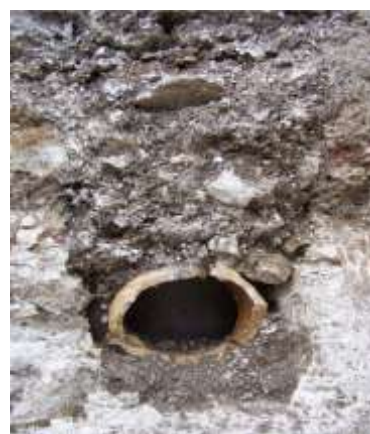
Figure 37: feature [7] scale 1:10

Slightly south of the centre of the western (east facing) section was an almost vertically sided cut feature, [7], 0.38 m wide at the top, 0.25 m wide at the base and 0.50 m deep in total (Figure 37). It contained a single uniform fill, (6), a brown sandy loam with large, angular chalk pebbles, which sealed a pale yellowish brown ceramic pipe 0.18 m in diameter externally. The feature was cut through deposit (5) and its fill was sealed by deposit (4).

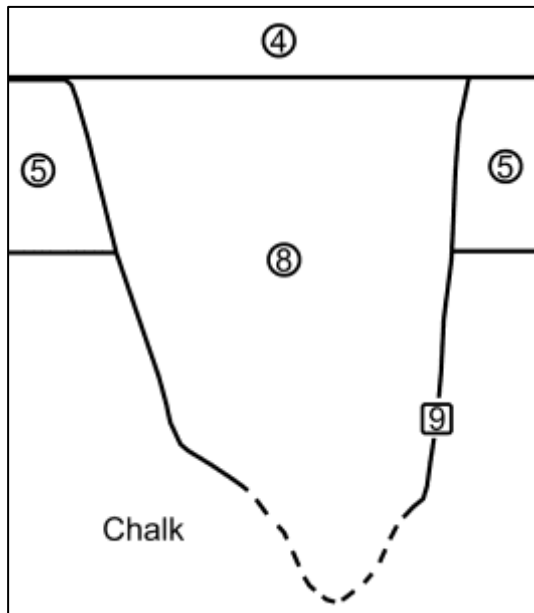
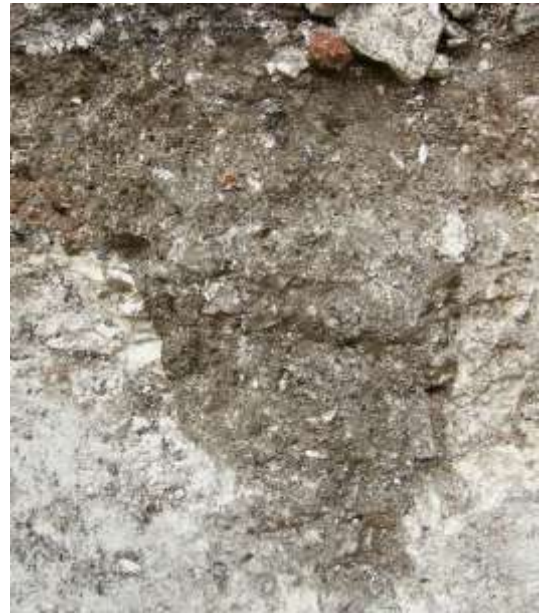
Figure 39: feature [9] scale 1:10

In the centre of the western (east facing) section, cut [9] had an almost vertical northern edge, a southern edge sloping at around 80° and a poorly defined base (Figure 39); it was about 0.50 m wide at the top, where it cut deposit (5), 0.32 m wide where it began to curve inwards towards its poorly defined base and up to 0.60 m deep. It contained a single fill, (8), a mid brown clay loam with numerous small flints and a few chalk pebbles; it was difficult to define the edges of the feature where it had cut through (5) owing to the similarity between its fill and that deposit.
