Observation of works at Fish Hill Square, Royston, Hertfordshire, 2011

North Hertfordshire District Council

Archaeological Report 37

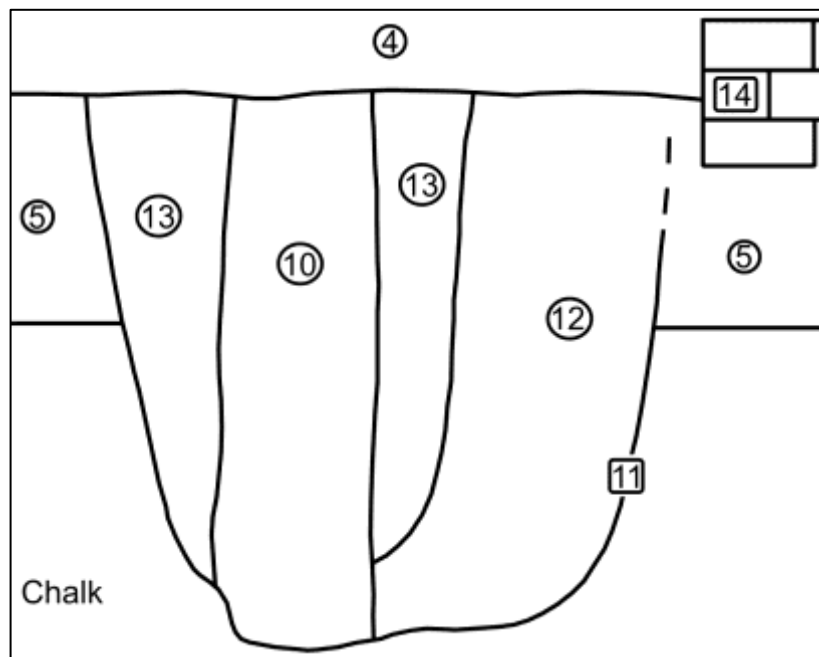
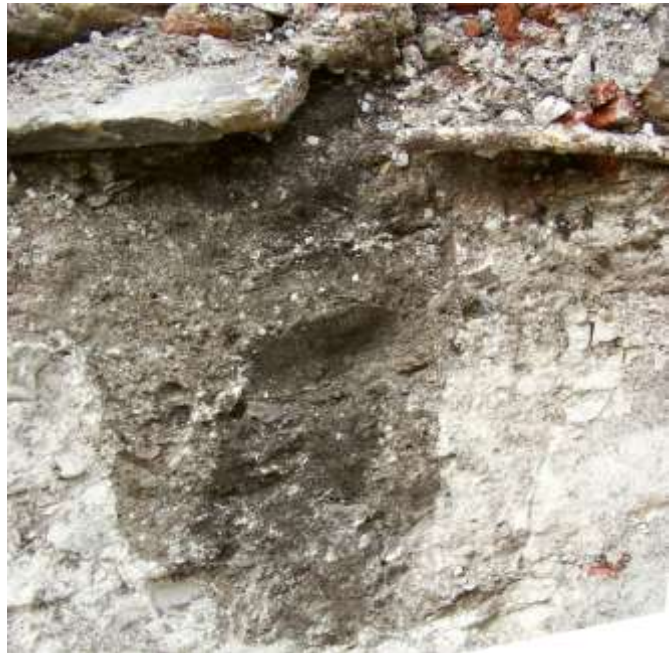
Figure 41: feature [11] scale 1:10

A U-shaped cut was observed north of the centre of the western (east facing section), about 0.80 m wide at the top, where it cut deposit (5), about 0.50 m wide at its base and 0.53 m deep (Figure 41). It contained two fills: (12), a deposit of chalk rubble, and (13), a light grey-brown clay loam. The latter surrounded (10), a dark brown deposit contained within a vertical post-pipe some 0.22 m wide. The upper part of the feature was obscured by rubble in deposit (4), which sealed it and the upper part of the northern

Given the size of the post, over 0.22 m wide, it is likely to have been a structural element rather than, say, a fence post. It must therefore have been part of a building that stood on this site, probably facing Market Hill, before the construction of the tenement buildings in the nineteenth century. As it cut deposit (5), which contained probably seventeenth-century bricks, the building can have been no earlier than that.

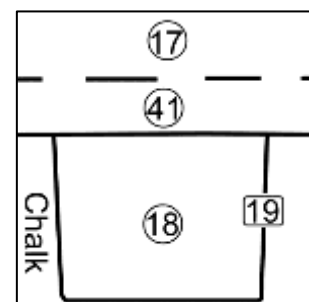
Figure 44: feature [19] scale 1:10

If it had been a structural element, it is unclear whether it was part of the same structure as posthole [11]. Its upper surface lay 0.60 m below the present ground surface and its base 0.80 m below; the top of posthole [11] lay 0.43 m below the present ground surface and its base 1.16 m below. Even allowing for truncation at the time The Cage was built in 1718 or the Jubilee Fire Station in 1897, the differences in levels suggest that they were parts of two separate structures. As with posthole [11], there was no direct dating evidence. However, if the deduction that the formation of deposit (41) pre-dated the construction of The Cage is correct, this would mean that [11] and [19] were roughly contemporary, even if they were parts of different buildings.

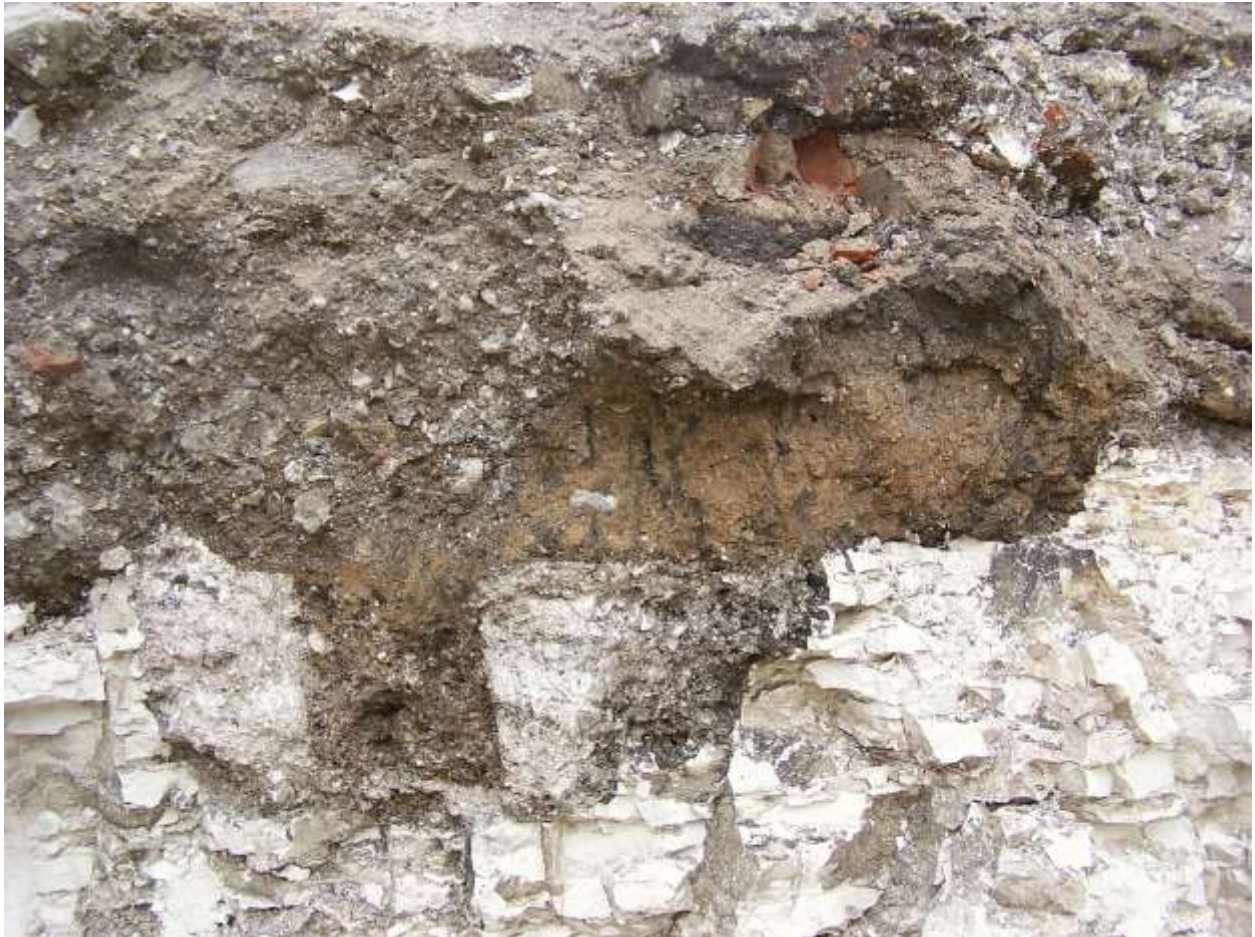
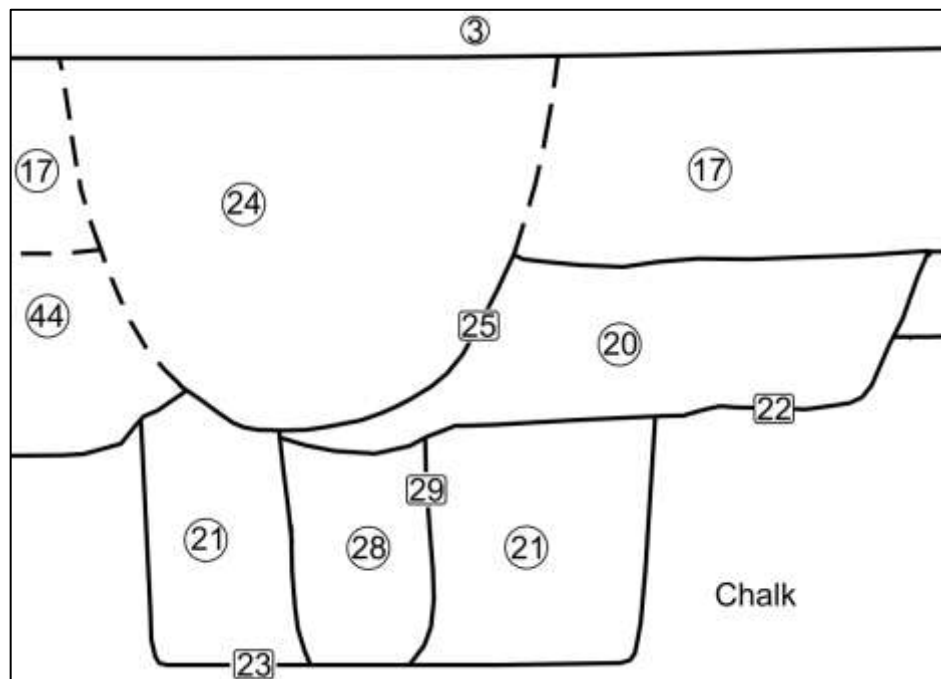
Figure 45: features [22], [23], [25] and [29] photograph

This feature was evidently a large post-hole, the visible part of the post-pipe probably not representing the full thickness of the post. The timber was evidently withdrawn before it decayed, as the fill contained no trace of organic staining. The base of the feature lay some 1.08 m below the present surface, a similar depth to

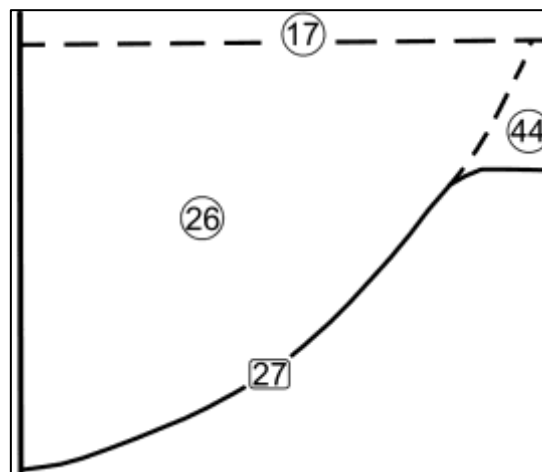
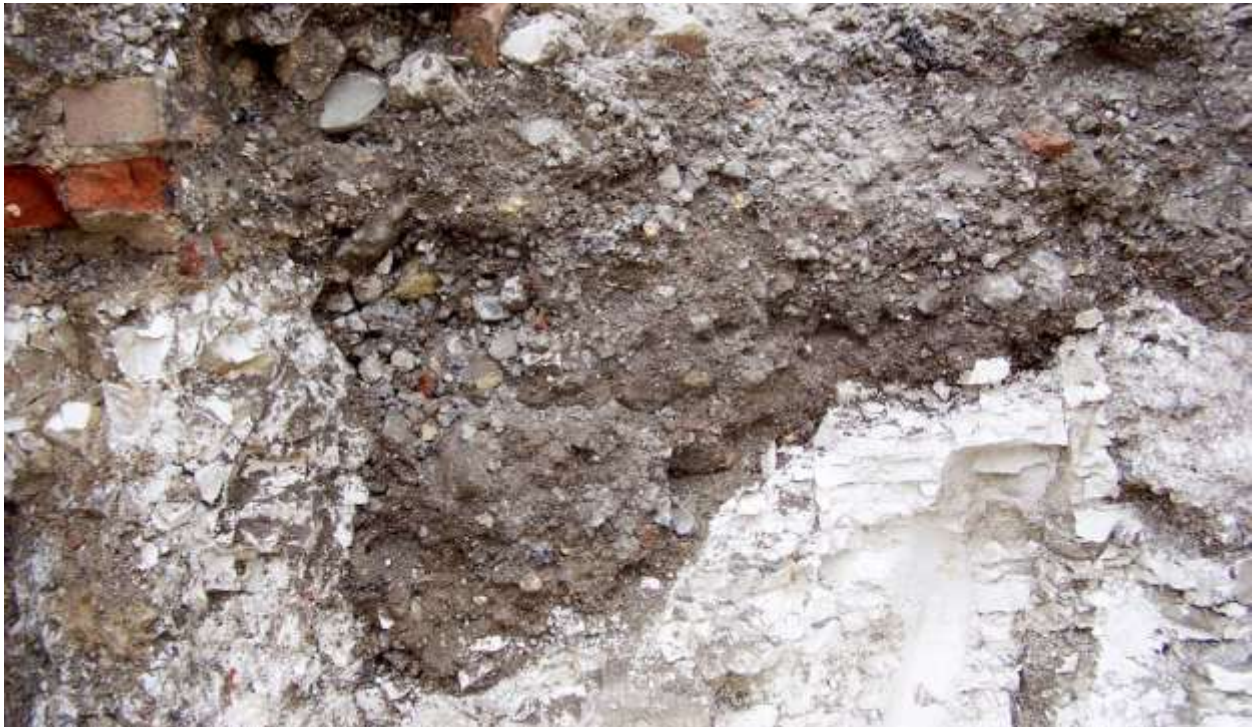
Figure 46: cut [27] scale 1:10

At the eastern end of the south (north facing) section was a cut feature that evidently extended beyond the eastern edge of the trench, where it abruptly rose vertically (Figure 47). It was about 0.67 m wide and 0.57 m deep, with a single, very mixed fill, (26), a grey-brown gritty loam containing significant quantities of rubble, although it was distributed in discrete patches rather than throughout the deposit.

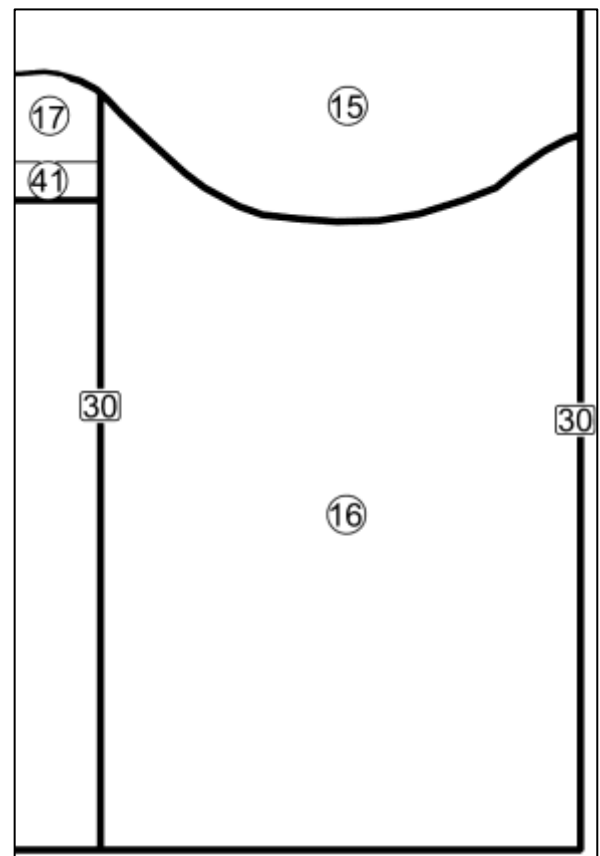
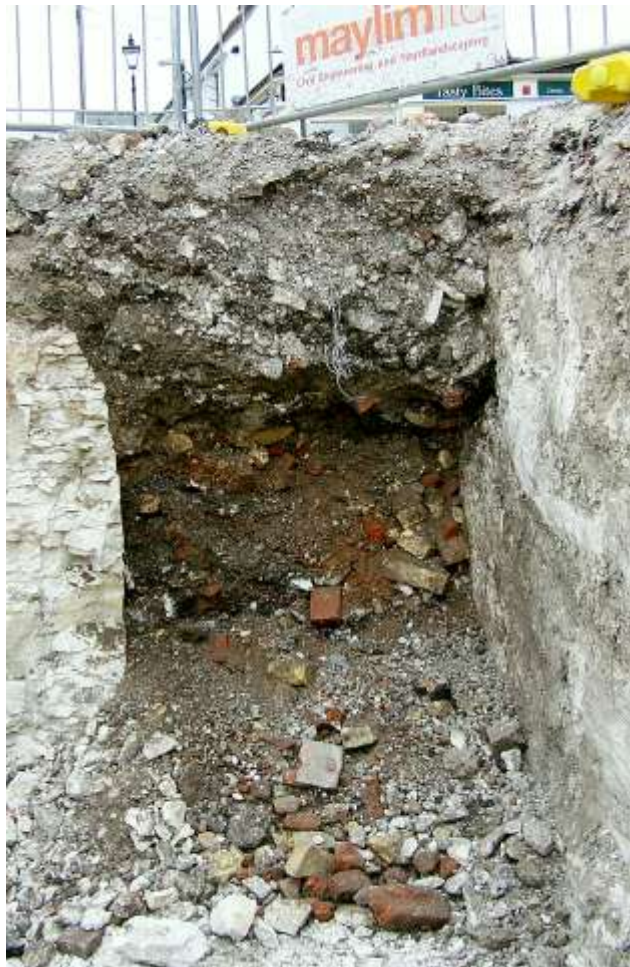
Figure 49: feature [30] scale 1:20

This feature appears to have lain beneath the north-western corner of the Jubilee Fire Station and must have been connected with its use, presumably in some kind of cellarage. Interestingly, there was no indication that there was ever a brick lining to this feature, which must have been either a passageway or, perhaps more likely, part of the stairwell leading down into a cellar. As it cut deposit (17), this means that (17) must pre-date the construction of the

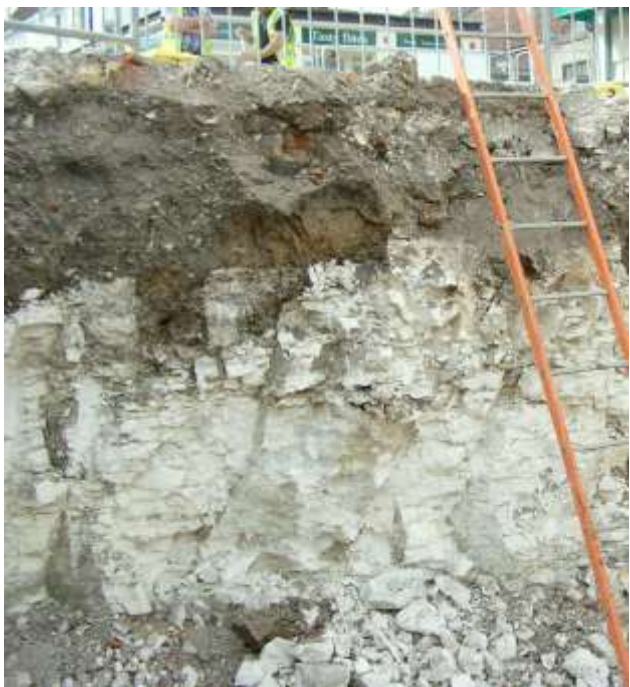
Figure 51: chalk bedrock on the south side of the trench

Undisturbed geological deposits were visible on all but the eastern edge of the trench. Only chalk rock was visible (Figure 51), with no trace of drift geology or of weathering deposits on its upper surface. This suggests that earlier deposits that may have formed above the deposits, including the topsoil pre-dating the growth of the town, had been removed at some point before the formation of the earliest deposits, (5) and (41), probably in the seventeenth century. This evident truncation is a phenomenon noted across the town, but for which no easy, single explanation can be suggested.
